RINGWOOD MINES/LANDFILL SITE

PUBLIC MEETING

December 6, 2016

August 2016 Groundwater and Surface Water Investigations

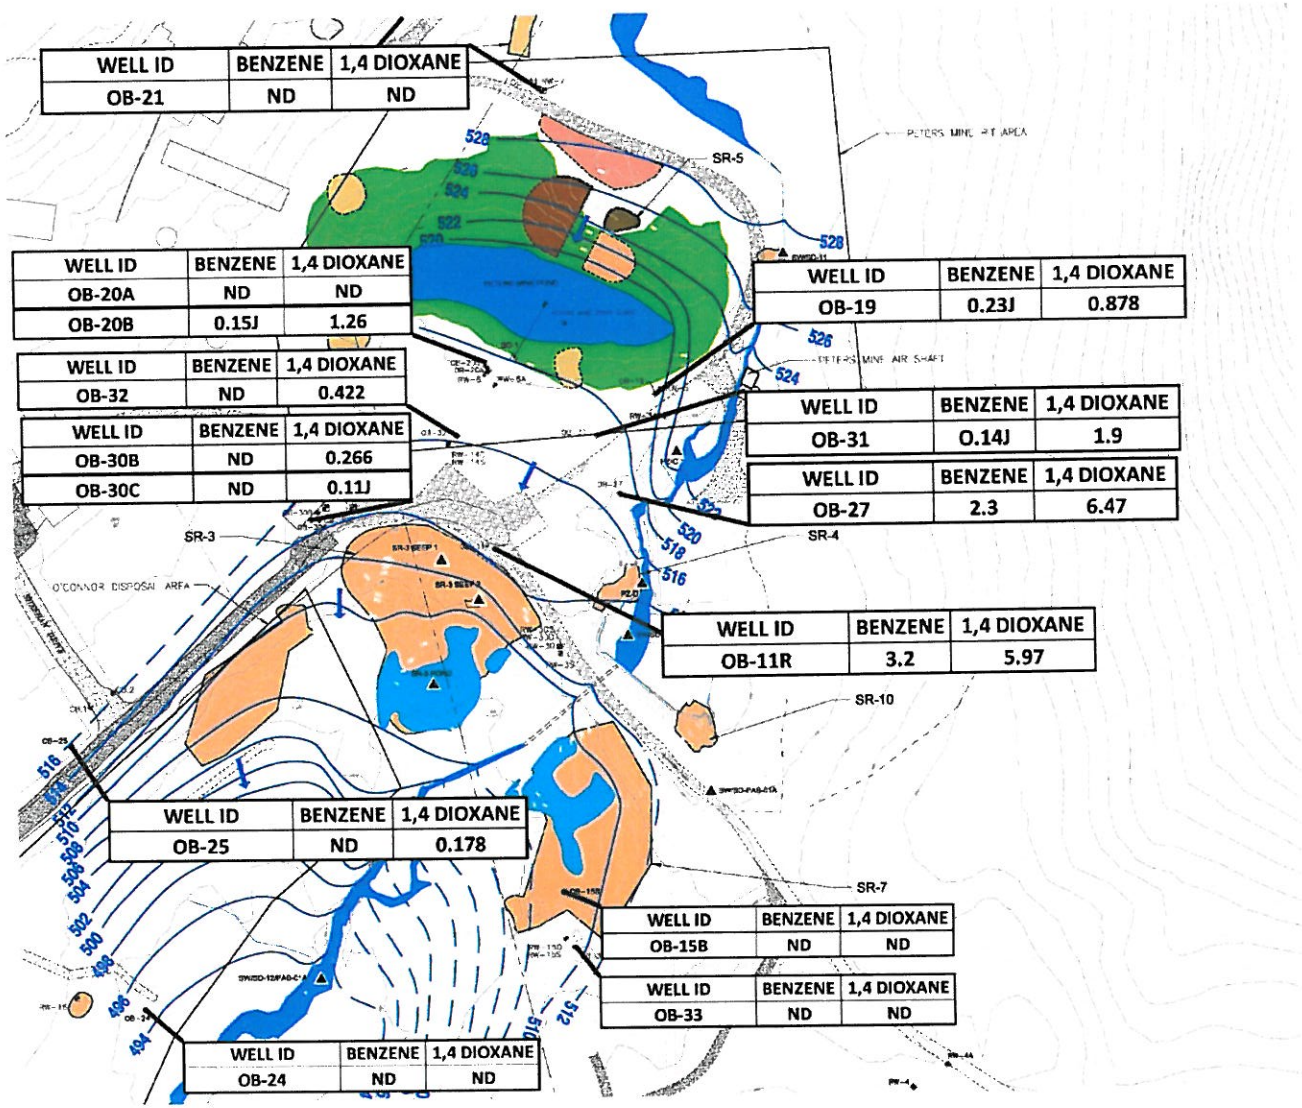
Peters Mine Pit Area
Overburden Groundwater, Benzene and 1,4-Dioxane
August 2016

- Consistent with the results of the August 2015 Groundwater Sampling Event, benzene and 1,4-dioxane were detected at their highest concentration in water samples collected from the bottom of the Peters Mine Airshaft.
- Benzene was detected at a concentration of 29 parts per billion (ppb) in the water sample collected from the bottom of the Peters Mine Airshaft. The drinking water standard for benzene is 1 ppb.
- Benzene was detected at a concentration less than 10 ppb in all other groundwater samples collected from the Peters Mine Pit Area.
- 1,4-dioxane was detected at a concentration of 146 ppb in the water sample collected from the bottom of the Peters Mine Airshaft, at a depth of 230 feet below ground surface (bgs).

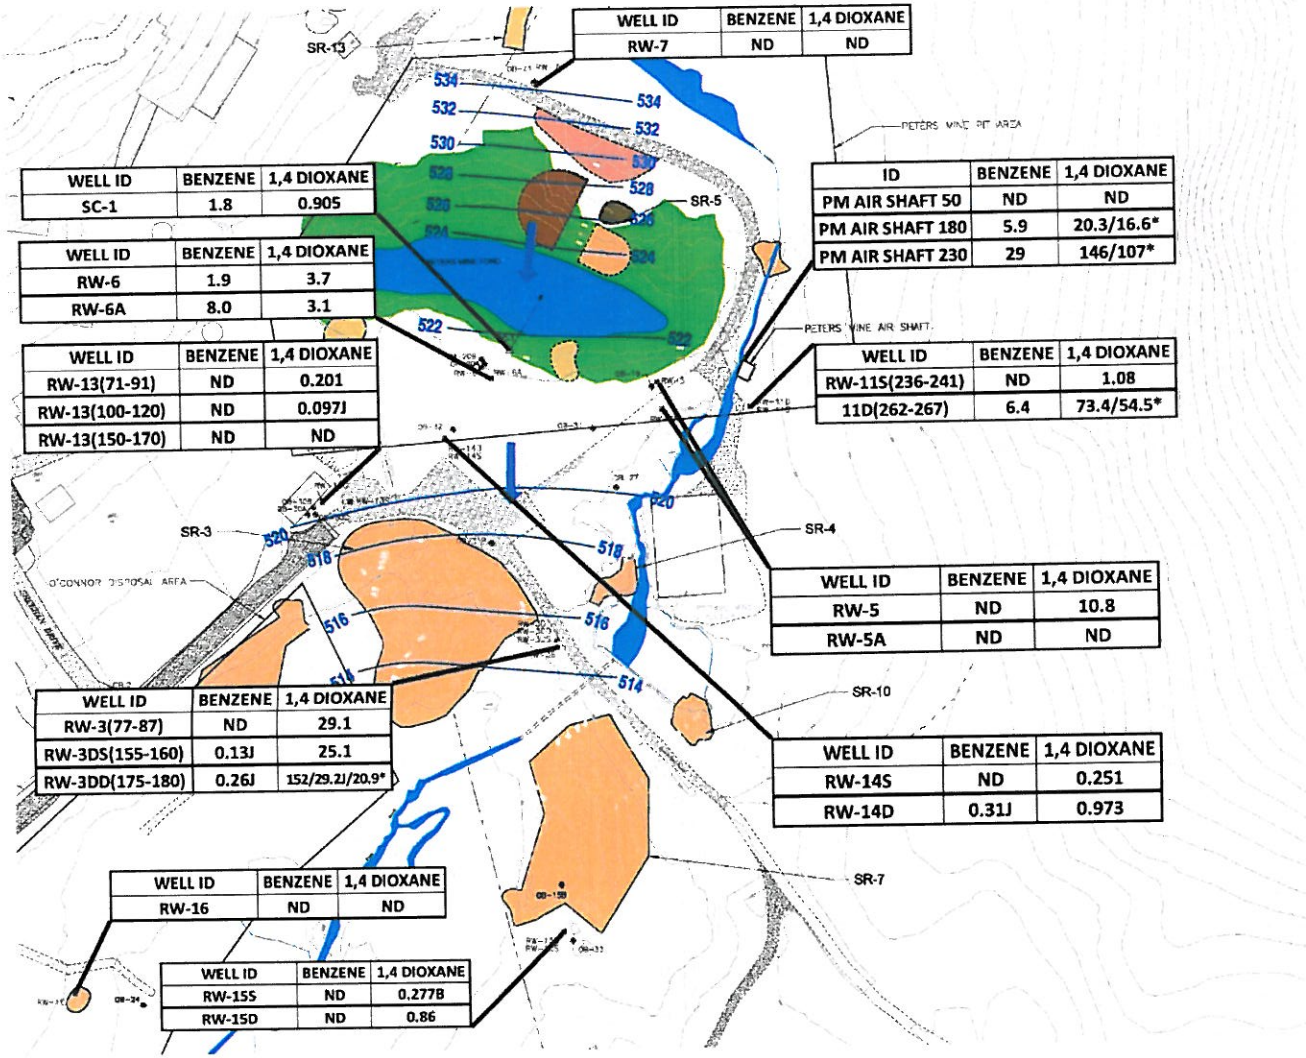
Peters Mine Pit Area
Bedrock Groundwater and Mine Water, Benzene and 1,4-Dioxane
August 2016

ID	BENZENE	1,4 DIOXANE
PM AIR SHAFT 50	ND	ND
PM AIR SHAFT 180	5.9	20.3/16.6*
PM AIR SHAFT 230	29	146/107*

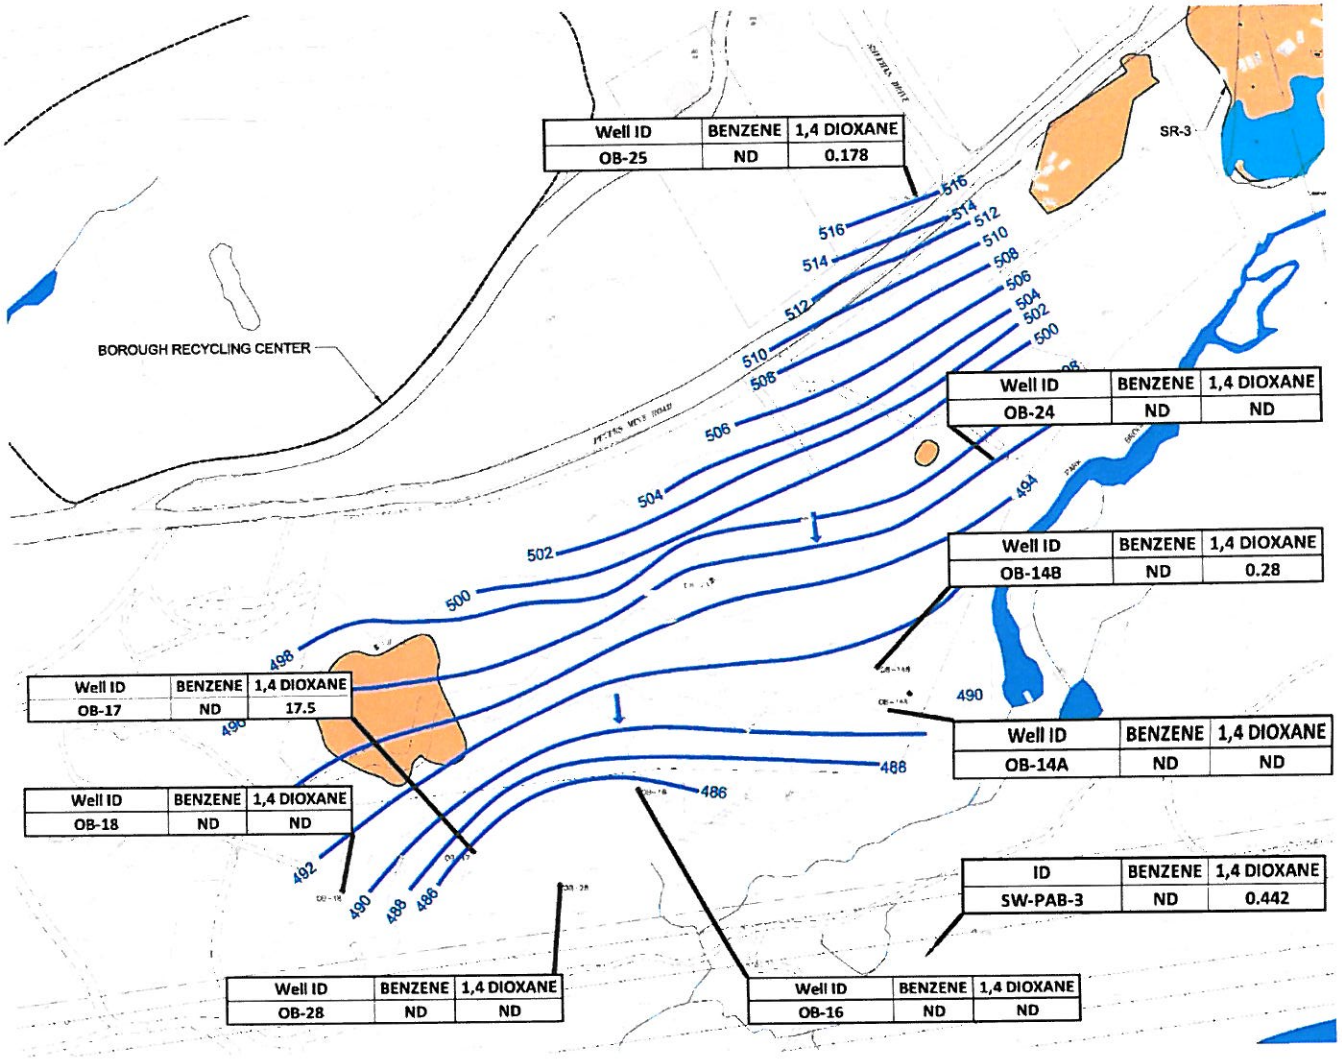
OCDA Groundwater Benzene and 1,4-Dioxane
August 2016

- Volatile organic contaminants, including benzene, were not detected at concentrations which exceed groundwater or drinking water standards.
- 1,4-Dioxane was detected at a concentration which exceeds the State of New Jersey's Interim Groundwater Quality Standard of 0.4 ppb in one sample collected from the southern end of the O'Connor Disposal Area.
- 1,4-Dioxane was detected at a concentration of 17.5 ppb in this groundwater sample. 1,4-Dioxane was detected at a concentration of 17.0 ppb in a sample collected from the same monitoring well during the August 2015 Groundwater Sampling Event.

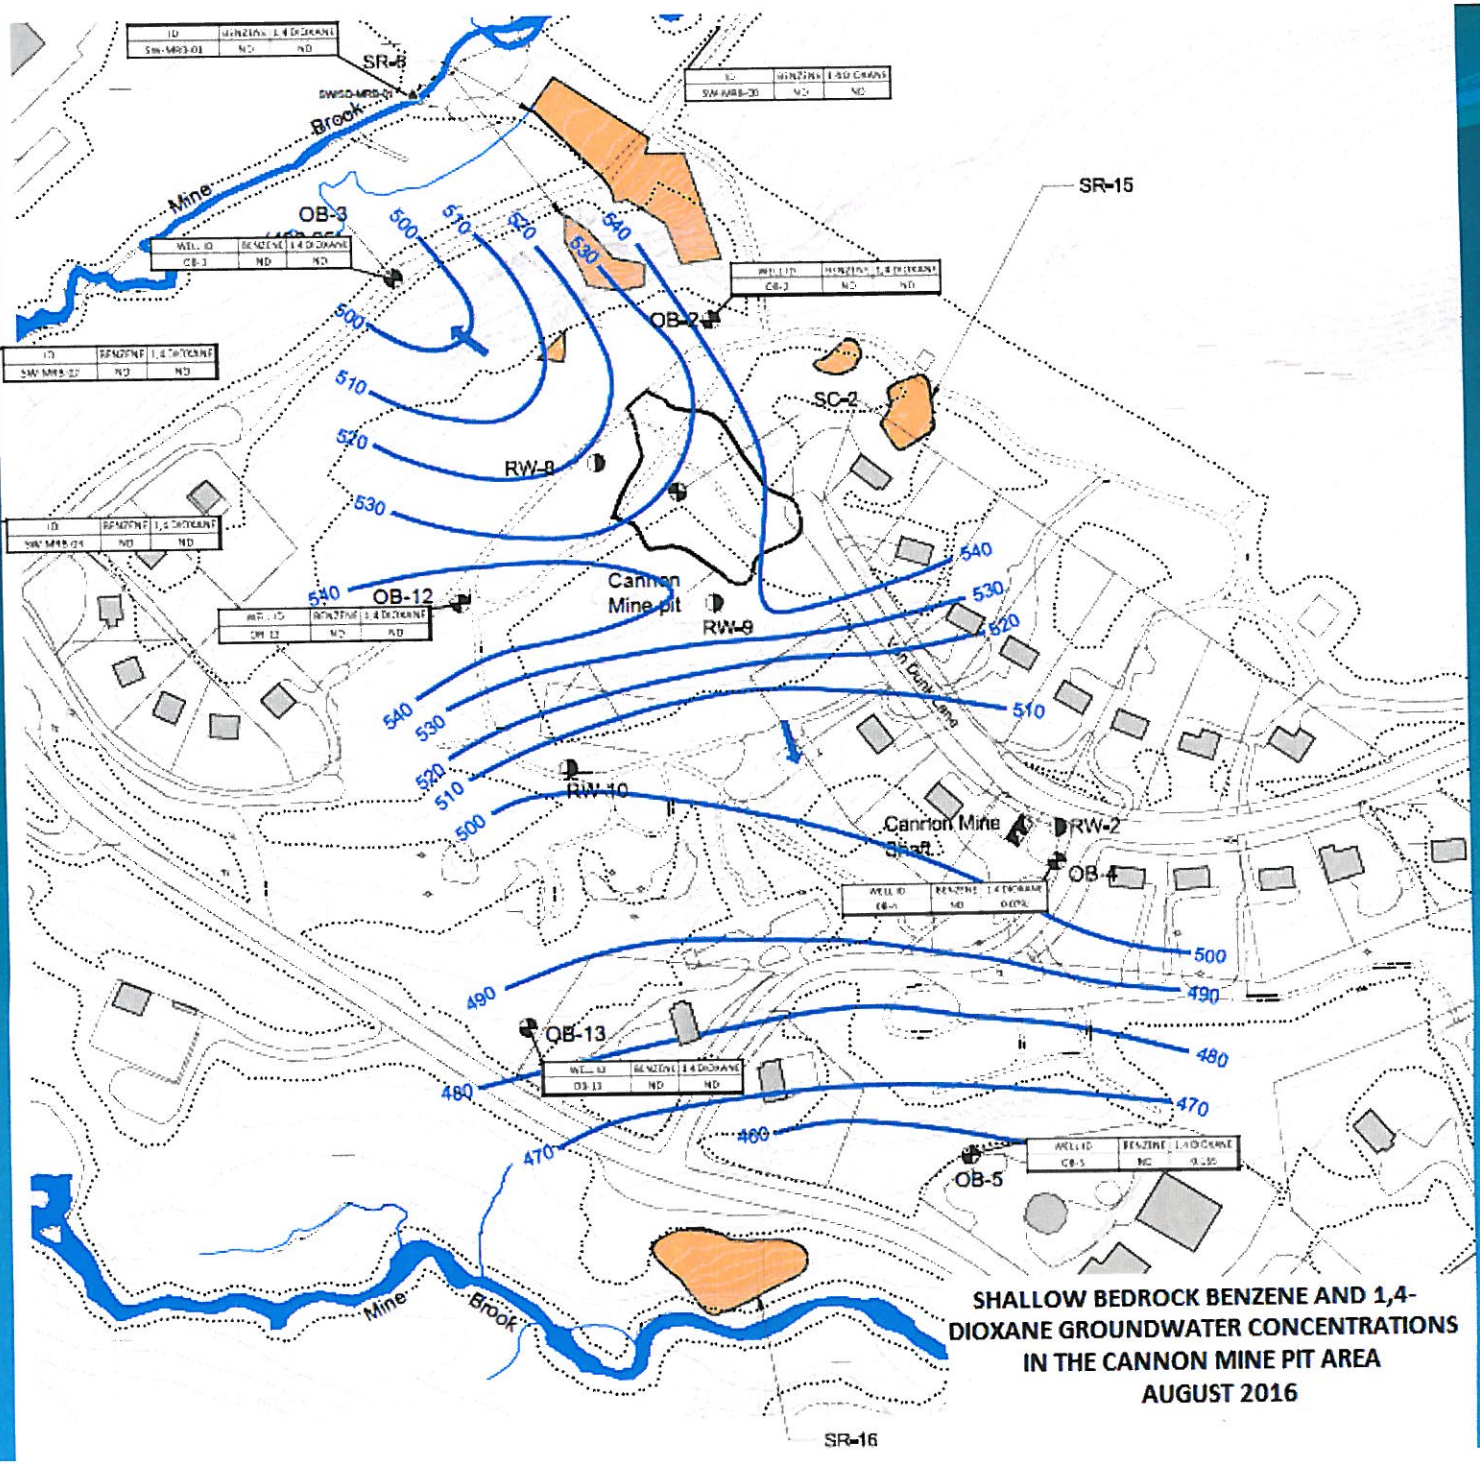
- Benzene was detected at a concentration which exceeds its drinking water standard of 1 ppb in only one groundwater sample collected from the Cannon Mine Pit Area. Benzene was detected at a concentration of 3.8 ppb in this sample, which was collected at a depth of over 200 feet below ground surface.

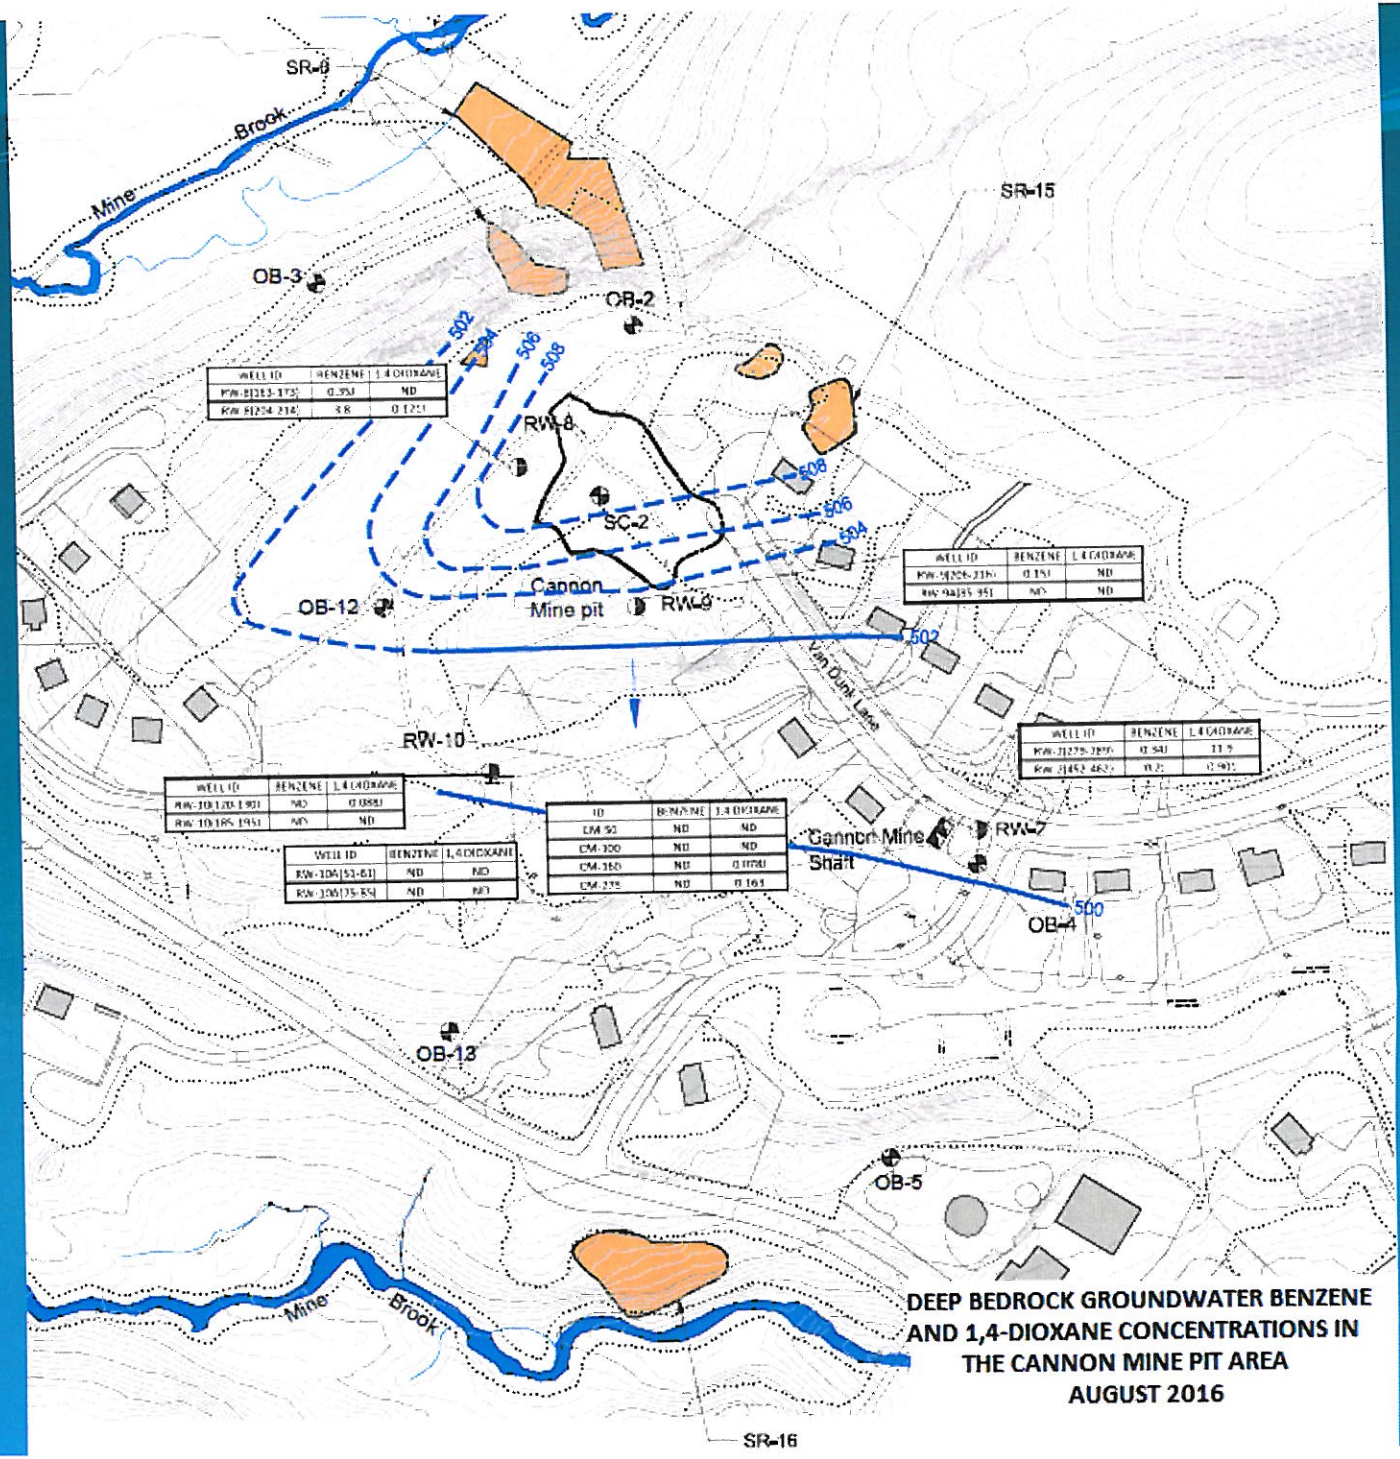
DEEP BEDROCK GROUNDWATER BENZENE AND 1,4-DIOXANE CONCENTRATIONS IN THE CANNON MINE PIT AREA AUGUST 2016

- 1,4-Dioxane was detected at a concentration which exceeds the State of New Jersey's Interim Groundwater Quality Standard of 0.4 ppb in two wells in the Cannon Mine Pit Area. These samples were collected at depths greater than 270 feet below ground surface. Samples collected from these wells during the August 2015 groundwater sampling event also exceeded the 0.4 ppb standard.

- Polychlorinated biphenyls (PCBs) were detected in one sample at a concentration that slightly exceeded the New Jersey Groundwater Quality Standard of 0.5 ppb. This sample was collected at a depth greater than 450 feet below ground surface.

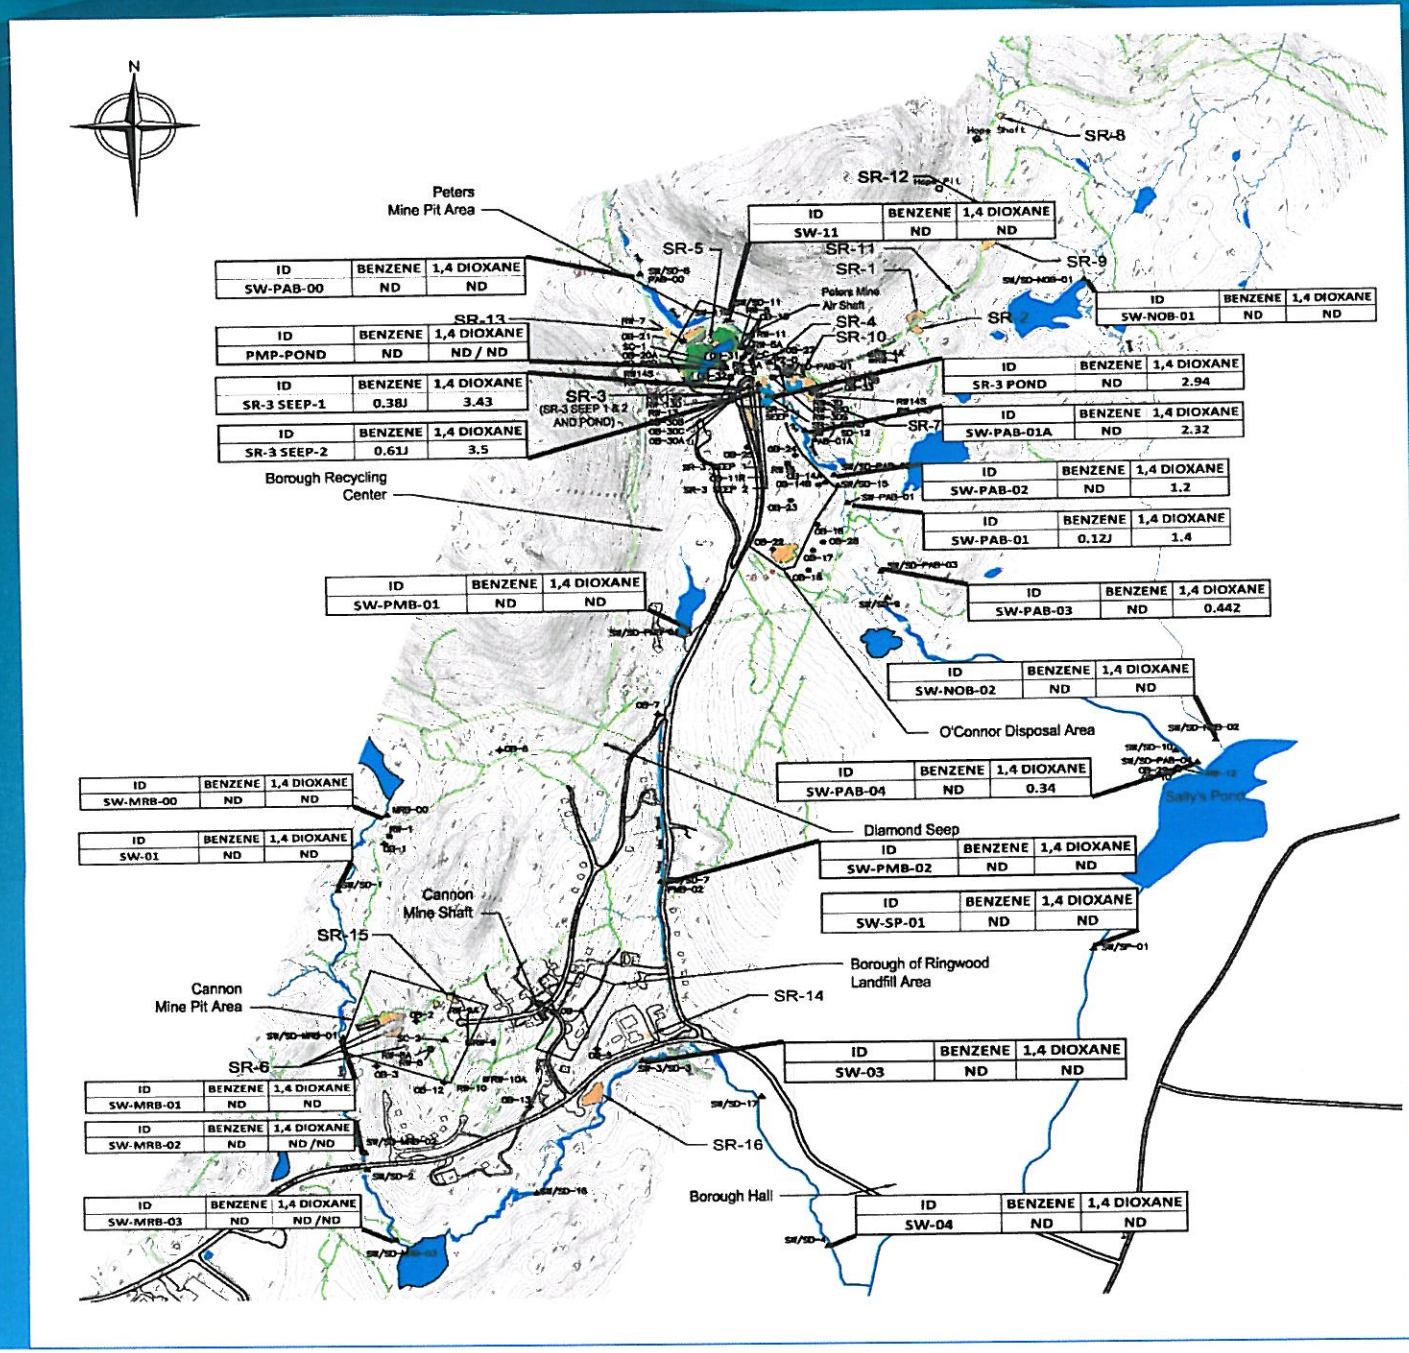
Surface Water Benzene and 1,4-Dioxane – August 2016

- Surface water samples were collected from groundwater seeps, on-site ponds and the four brooks present at the site.
- Of the four brooks sampled, 1-4 Dioxane was only detected in the Park Brook.
- 1,4-Dioxane was detected in the Park Brook at concentrations up to 2.32 ppb at on-site brook locations, and up to 0.34 ppb at off-site locations. 1,4-Dioxane was not detected at sample locations downstream of Sally's Pond.
- Benzene was not detected in any of the surface water samples collected from the four brooks present at the site.
- Benzene was detected in the two groundwater seeps at concentrations less than 1.0 ppb.

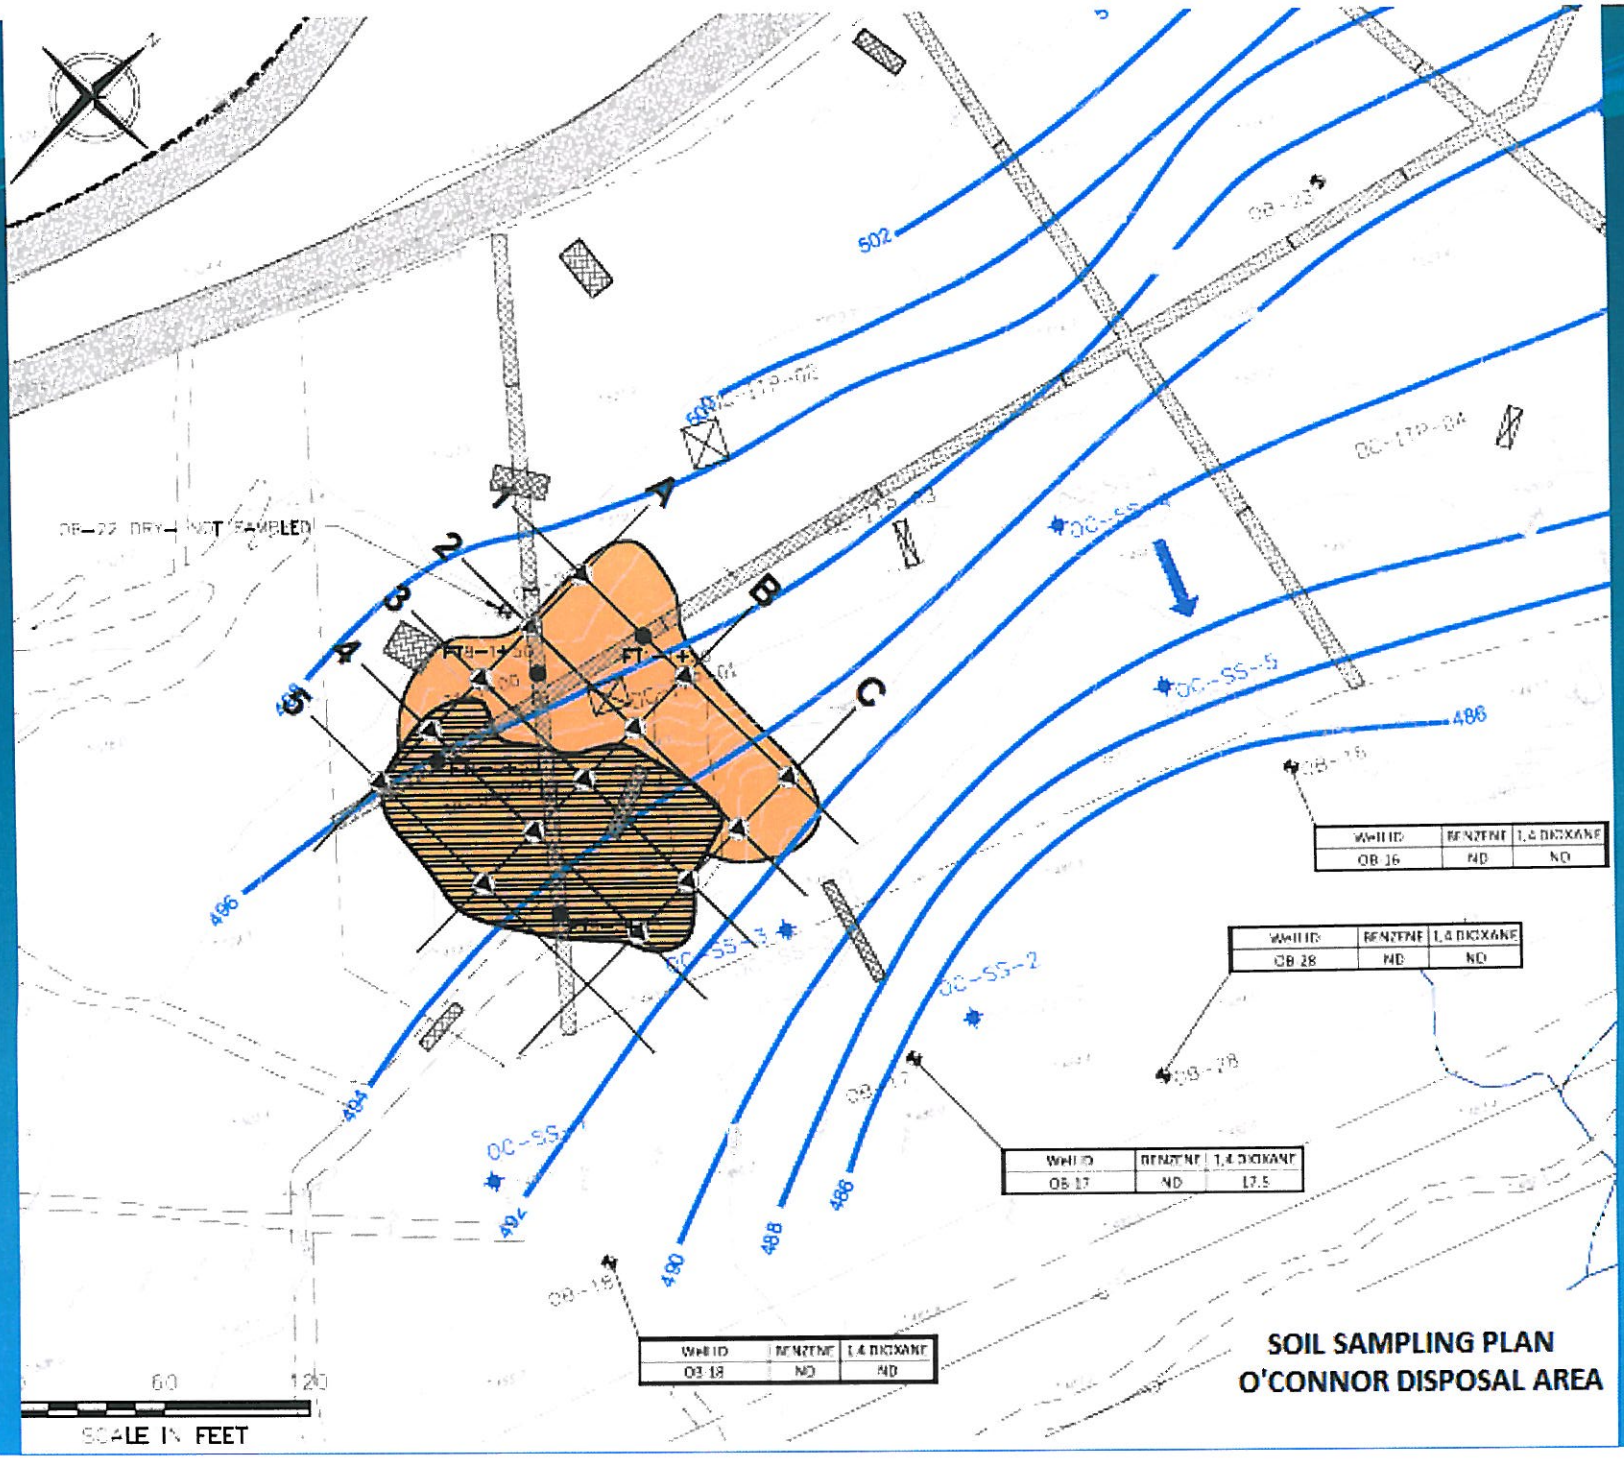
- Due to the isolated detection of 1,4-Dioxane in one well at the southern end of the O'Connor Disposal Area, the Ford Motor Company has proposed the collection of additional soil samples to evaluate whether a source of 1,4-Dioxane remains in the OCDA.
- The soil sampling will target an area of the OCDA where paint sludge had been previously removed.
- The soil sampling plan calls for the installation of 14 soil borings, with the collection of 50 to 55 soil samples.
- The soil sampling will begin during the week of December 12, 2016.
- EPA anticipates that the sampling results will be available in January.
